SAFETY BULLETIN No.1 of 2012

NARROWBOAT SINKING INADEQUATE VENTS/FREEBOARD

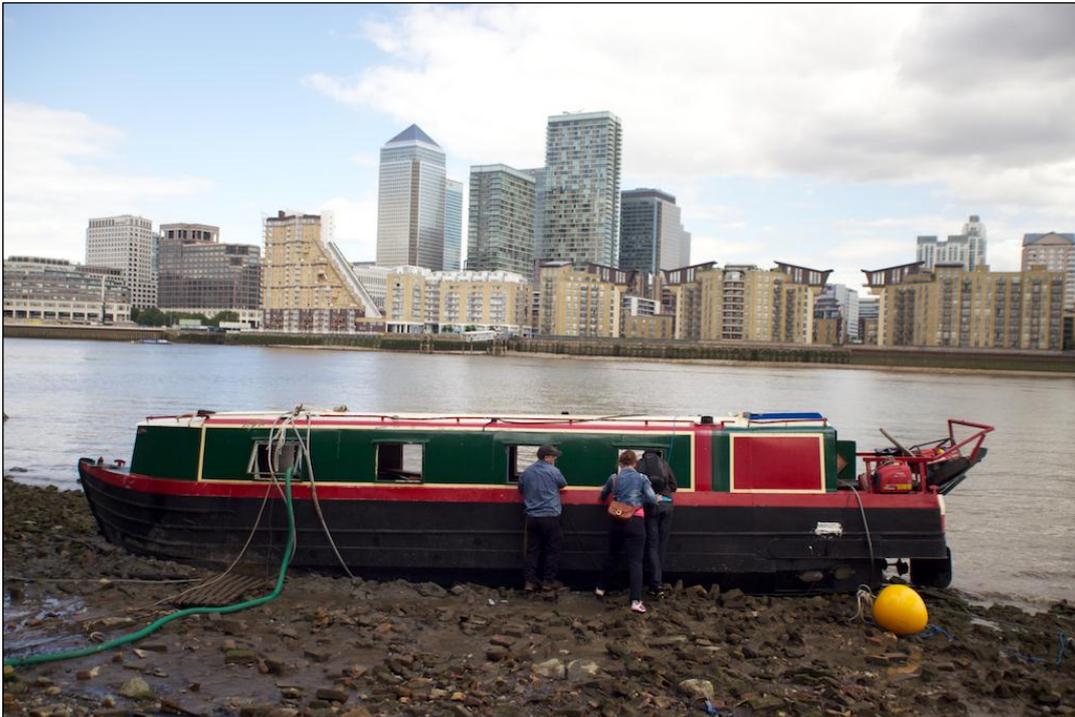
Shortly into their transit the crew noted a change in the engine note and opened the engine room hatch to find the engine half submerged. All persons quickly moved to the stern to try and bail out the engine room, but were unable to cope with the ingress of water into the vessel. The engine room continued to fill with water and flooded into the main cabin, submerging the aft coaming below the water, resulting in severe flooding of the vessel which sank within 10 seconds. All of the crew and the dog entered the water without lifejackets, but were rescued by a nearby RIB and Police Launch.

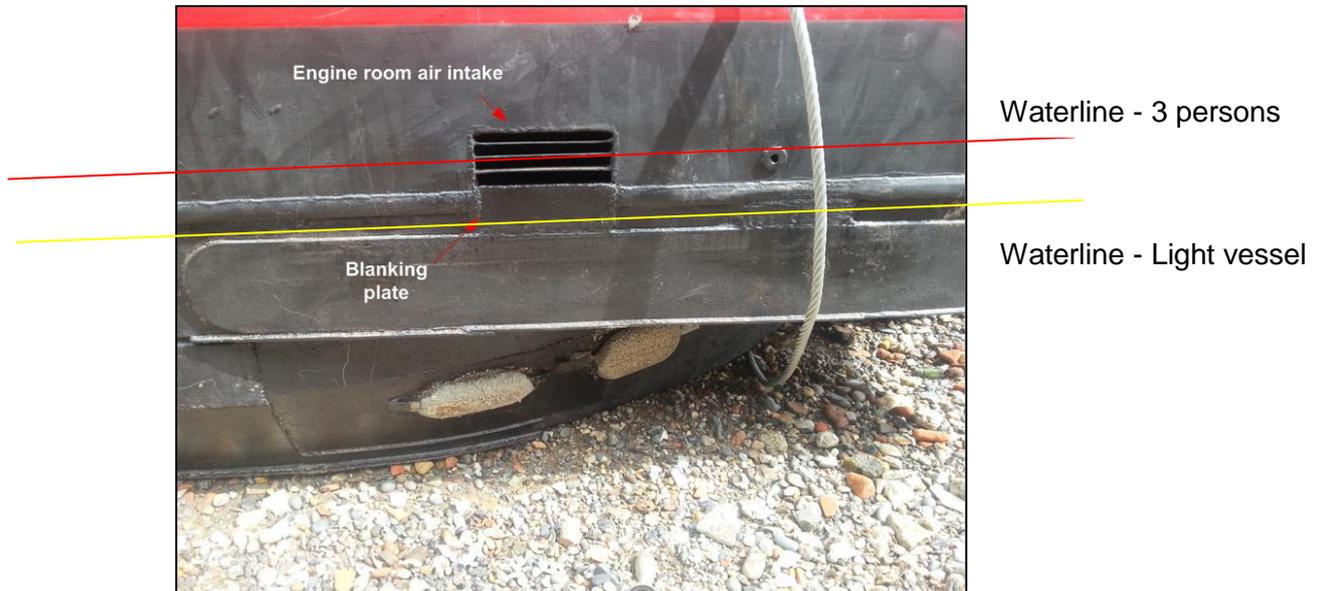
The hull of the vessel had been completely double plated and the increased weight of this plating had resulted in a reduced safety clearance; with the bottom of the engine room vent being positioned approximately 65mm above the waterline. With 3 persons positioned on the aft deck the bottom of the engine room air vent became submerged beneath the waterline by 50mm, the resulting downflooding and sinking of the vessel was inevitable.

2. Through hull fittings, vents and exhaust outlets should be positioned as high up as practicable on narrowboats to meet the conditions likely to be encountered. Where through hull fittings, vents and exhaust outlets cannot be moved to a safe location consideration should be given as to whether the vessel is suitable to navigate on the tidal Thames.

3. Where modifications have been made to a vessel, such as the extensive use of double plating, it is important to check that sufficient safety clearance remains for the vessel to safely navigate in the intended waterway.
