# SAFE BOARDING WEEK

27.02.23 - 05.03.23

# Results Breakdown

**Safe Boarding Week 2023** was a European-first safety initiative conducted by the Port of London Authority, from 27th February to 5th March 2023.

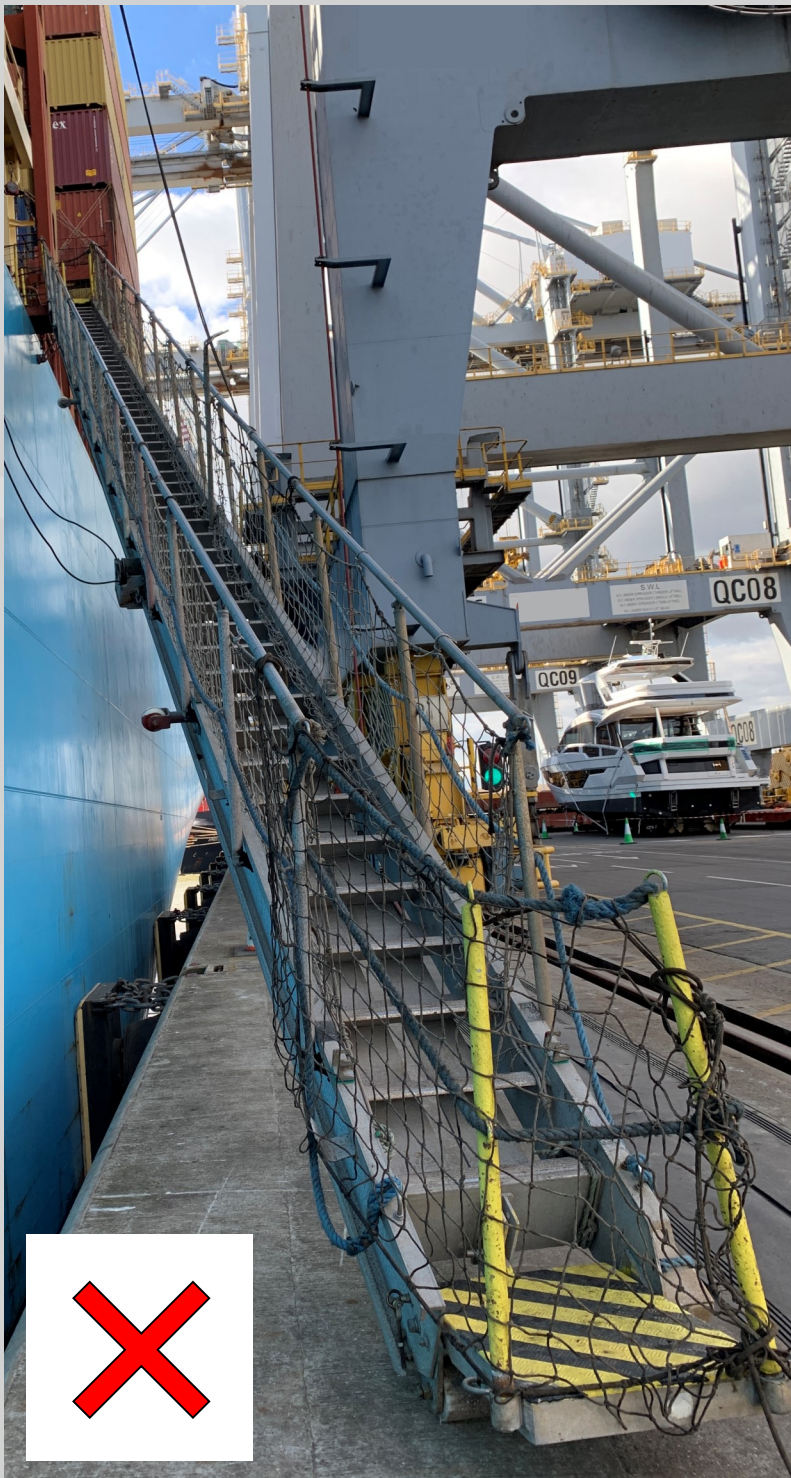
"It is a **common misconception** that gangways, like the one on the left, with a net that wraps around the gangway and only covers the sides and bottom do not require a separate safety net. This net will not catch you if you fall off, that is why you need a safety net like the one on the right which is fitted around the entire length of the gangway..."

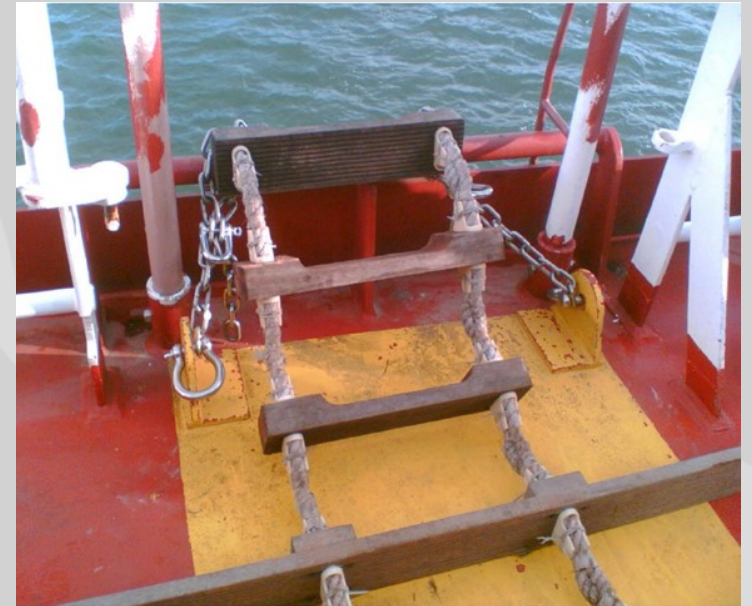
## Pilot Ladders secured by shackles

Pilot Ladders secured by **shackles** are a common deficiency.

This is because although the International Maritime Organisation allows it: **IMO A.1045(27):** 2.1.1 *"the securing strong points, shackles, and securing ropes should be at least as strong as the side ropes"* it must be noted the UK Authorities have declared the use of shackles as non-compliant, because this puts weight on the steps rather than the side ropes.

Pilot ladders should be secured using **rope lashings** to a deck strong point using a rolling hitch or appropriate hitch to secure the side ropes.

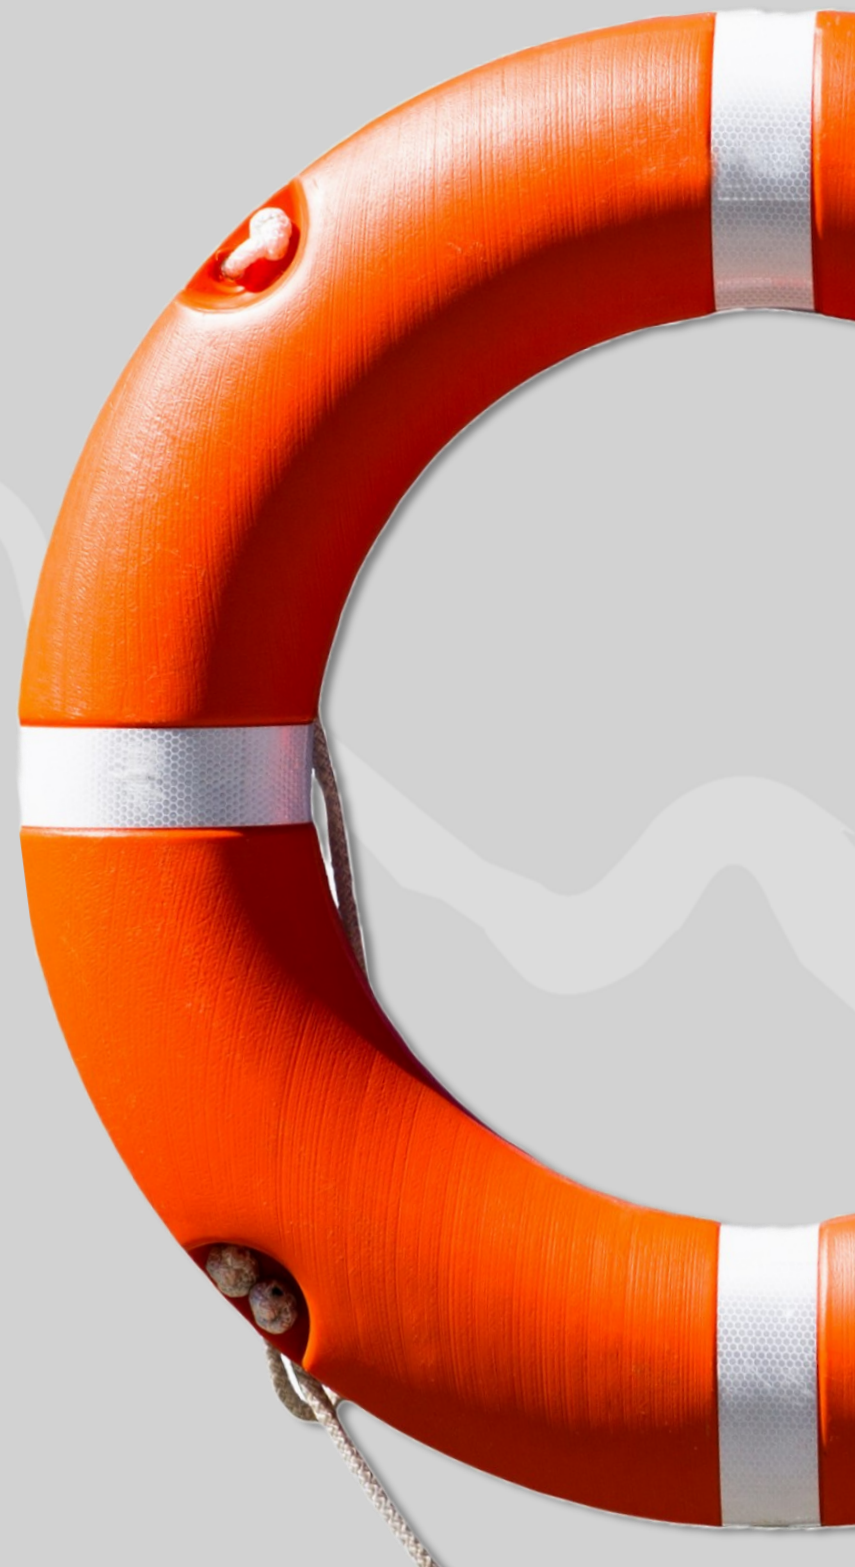
One of the aspects of the inspection was to check the location and condition of **lifebuoys** at the boarding points onboard vessels. Here is a summary of what we found.
