Port of London - River Thames

SAFETY BULLETIN No.5 of 2014

CLASS V SAFETY IMPROVEMENTS

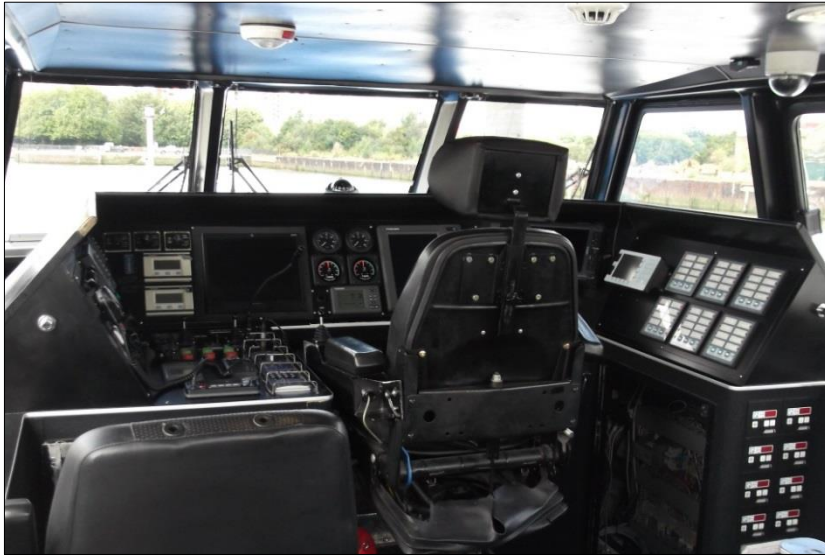
Wheelhouse Equipment and Ergonomics:

One incident highlighted the importance of a well laid out wheelhouse, as a Master reaching for a VHF Radio that was poorly positioned contributed towards an incident. It is important to ensure that regularly used equipment, such as the VHF Radio, are within easy reach from the normal conning position, so that when used, the control of the vessel is not compromised.

In addition, vital read-outs, such as rudder indicators and AIS displays should be clearly visible whilst navigating the vessel, without the need to move away from the controls. If

necessary, measures should also be implemented to prevent the effects of solar glare on display screens, to ensure their clear visibility in all conditions.

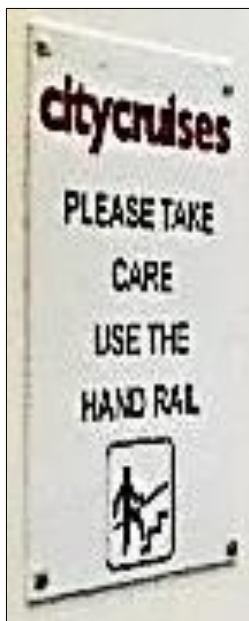
Stairwell Management

It can be dangerous for passengers to loiter on or around stairwells while vessels are underway, and particularly during vessel manoeuvres, such as berthing alongside a pier. The use of bar staff or other crew to monitor these areas should be considered at these times, along with the use of a Safety Announcement, advising passengers to remain seated whenever there is a risk of sudden movements to the vessel, or a heavy contact from coming alongside a pier and to use handrails at all times when using stairs.

The suggestions above echo the recommendations made in a safety alert issued by the National Transportation Safety Board (NTSB) on July 8 2013, concerning falls in stairways after the passenger vessel 'Seastreak Wall Street' made heavy contact while berthing at a pier in New York. A number of passengers were injured, including one passenger who sustained serious injuries; including a broken neck. Further information can be found at the following link: <http://www.nts.gov/news/2014/140408c.html>
