Port of London Authority: Maintenance Dredge Protocol and Water Framework Directive Baseline Document

Name	Data
Document Registration No	R.2238a
Document Type	Final Report
Authors	CA Roberts, BJ Carroll, PS Lomax, A Bowles, NM Warke, ES Martin, CE Brown
QC	MJ Smedley

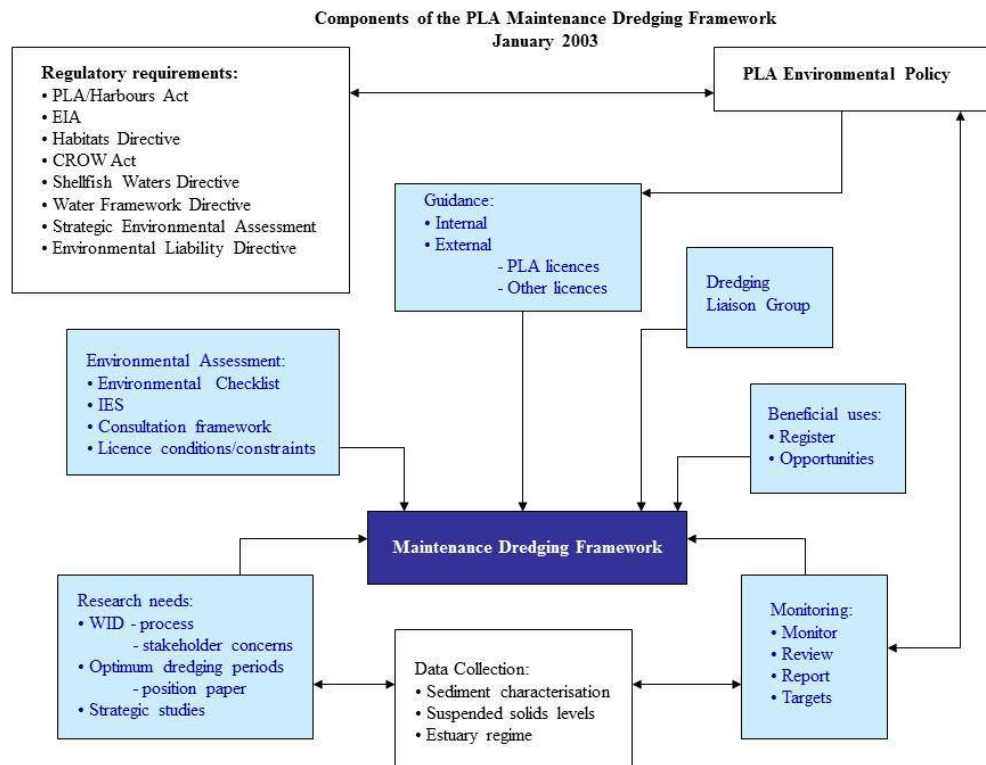
Image 4.1 PLA Maintenance Dredging Framework for the Thames Estuary

A key component of the Framework was the development of the Geographical Information System (GIS) Dredging Spatial Information System (DSIS). The DSIS facilitates the sharing of information and produces a baseline of relevant environmental data for the tidal Thames. DSIS is available to members of the Dredging Liaison Group via a secure connection on the PLA's website. Much of the current and historic dredging information and sediment contamination summary information presented in Sections 6 and 7 have been sourced through DSIS, supplemented by stakeholder and third party operator liaison where required.

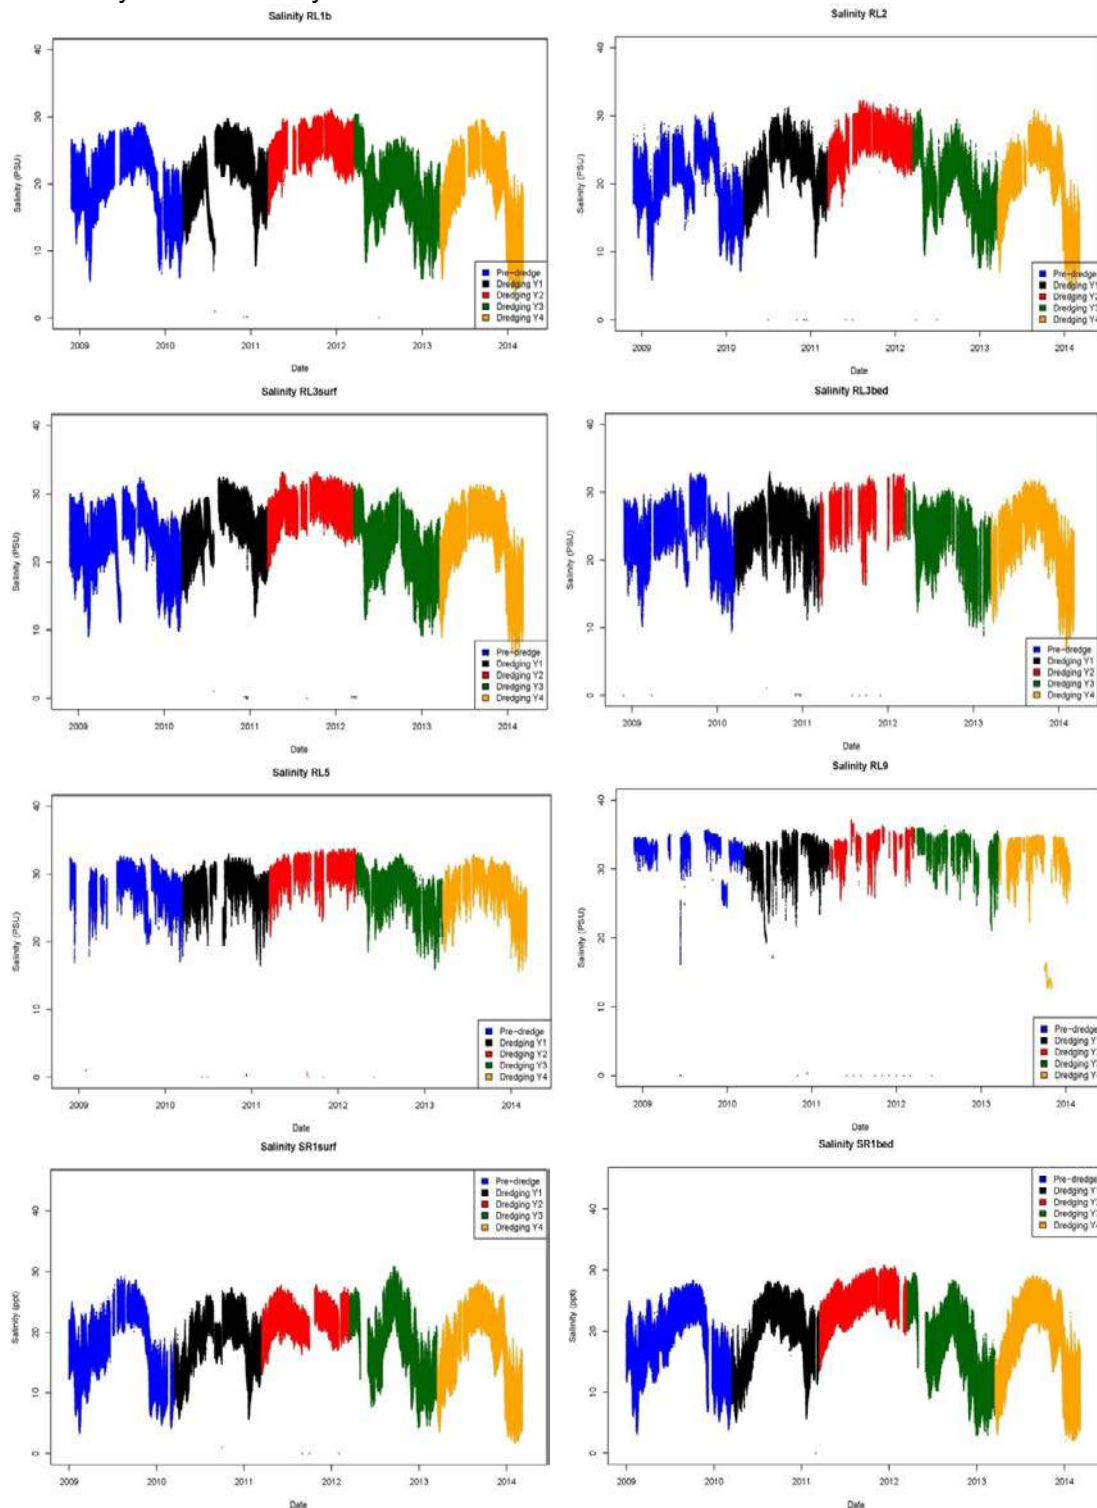
Image 5.1 London Gateway salinity monitoring (2009 – 2014)

As part of the London Gateway development, DP World undertook salinity monitoring along Lower Hope Reach and Sea Reach for a period of five years, the results of which are shown in Image 5.1 for a number of locations; see Image 5.2 for positions. The monitoring included pre-dredge (blue) and a subsequent four year period when capital dredging was ongoing. The monitoring results clearly illustrate a seasonal pattern in salinity at all locations, which is typically less in the winter months (i.e. November to January), increasing through the spring and summer (with maximum salinity around August). This pattern is driven by the relationship between fresh and saline water volumes, i.e. the additional input of freshwater during periods of increased rainfall (typically winter) will lower the salinity within the reaches of the Thames. This pattern does, however, vary significantly along the Thames as the saline water becomes increasing dominant in a downstream direction away from freshwater sources (e.g. Teddington). The monitoring data in Image 5.1 would also

tend to suggest that the London Gateway development had no significant effect on salinity within this section of the Thames Estuary, i.e. all changes are within natural variability over the five-year dataset.

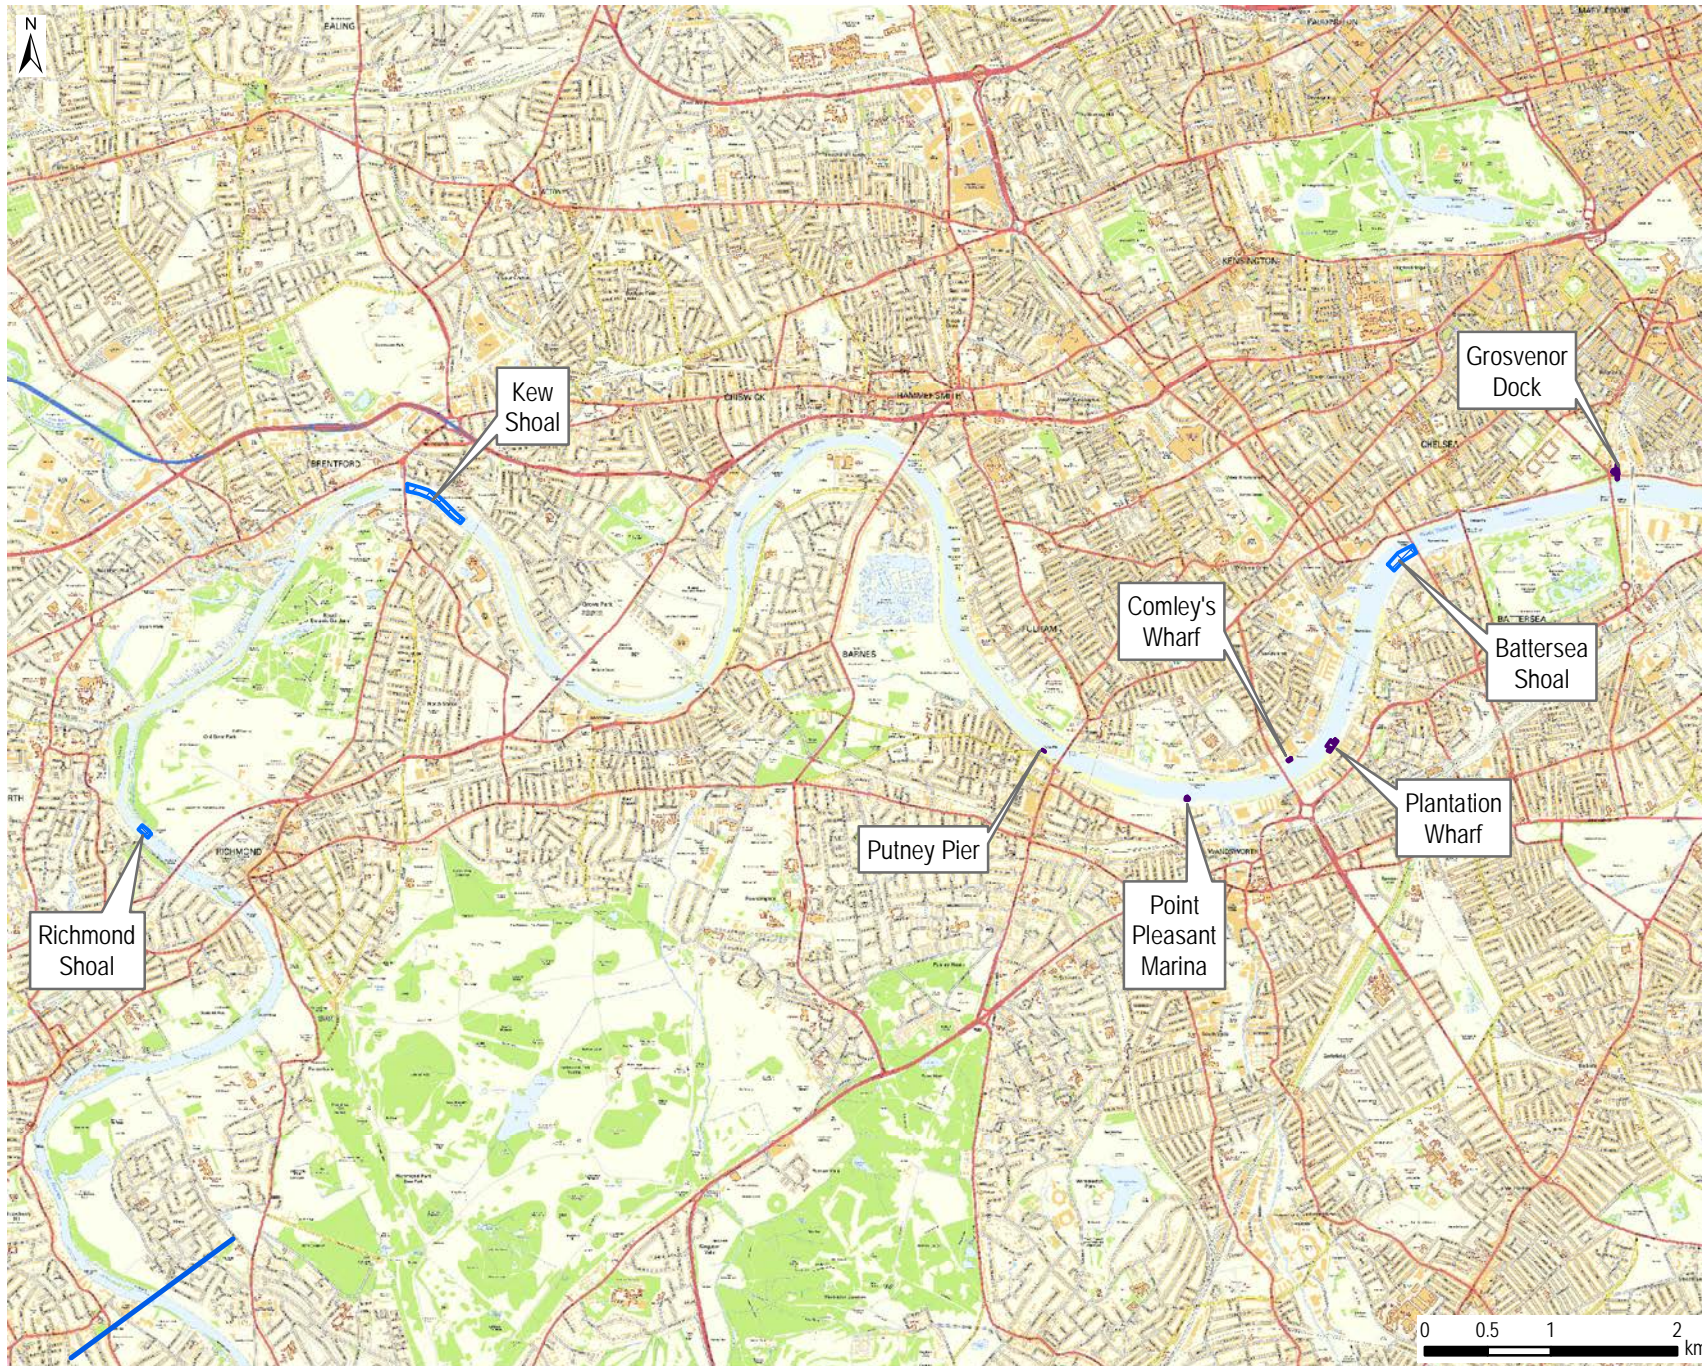
Dredge Locations (5)

Organisation: Day Aggregates
Dredge location: See Figure 6.6
Current max. dredge depth: 0.3 m below CD
Dredging frequency: Every 1 to 3 years
Material type: Silt
Dredging technique: Various, most recently HDM

Organisation: Canal and River Trust
Dredge location: See Figure 6.6
Current max. dredge depth: 4.7 m below CD (Lock Entrance)
Dredging frequency: Every 6 months
Material type: Silt
Dredging technique: WID (Van Oord)

Organisation:	KPMG Thames Clippers
Dredge location:	See Figure 6.6
Current max. dredge depth:	1.5 m below CD
Dredging frequency:	Every 6 months
Material type:	Silt/sand
Dredging technique:	WID (Van Oord), Backhoe (G.P.S. Marine), Plough (Westminster)
