SAFE BOARDING WEEK

04.03.24 - 10.03.24

PORT OF
LONDON
AUTHORITY

Results Breakdown

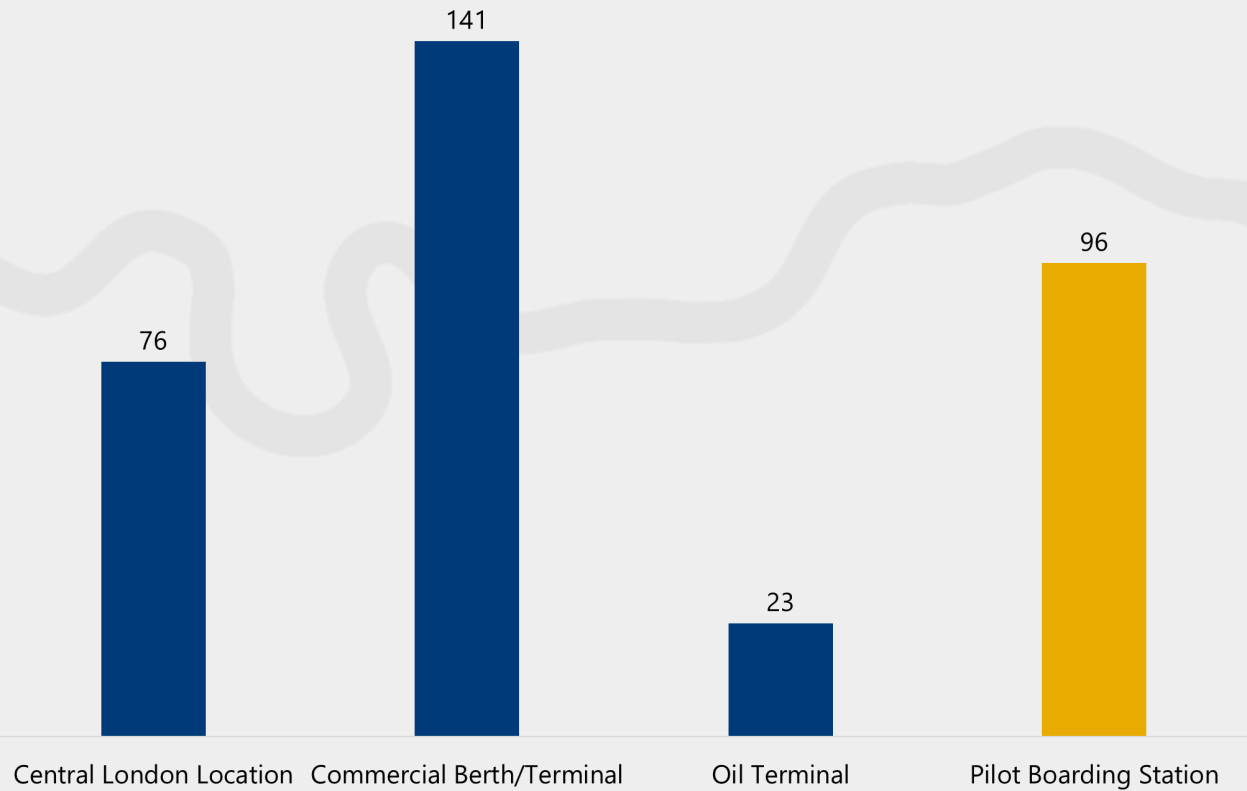
54 Location along the tidal Thames

On the left you can see a breakdown of our inspections by general location.

The **blue** bars show the number of inspections carried out by colleagues in the Chief Harbour Master’s management team and afloat staff (**240**) who visited commercial berths, piers, wharves and jetties.

The **yellow** bar depicts inspections conducted by our Pilots when boarding commercial vessels at Pilot Boarding areas in the Estuary and lower Thames (**96**).

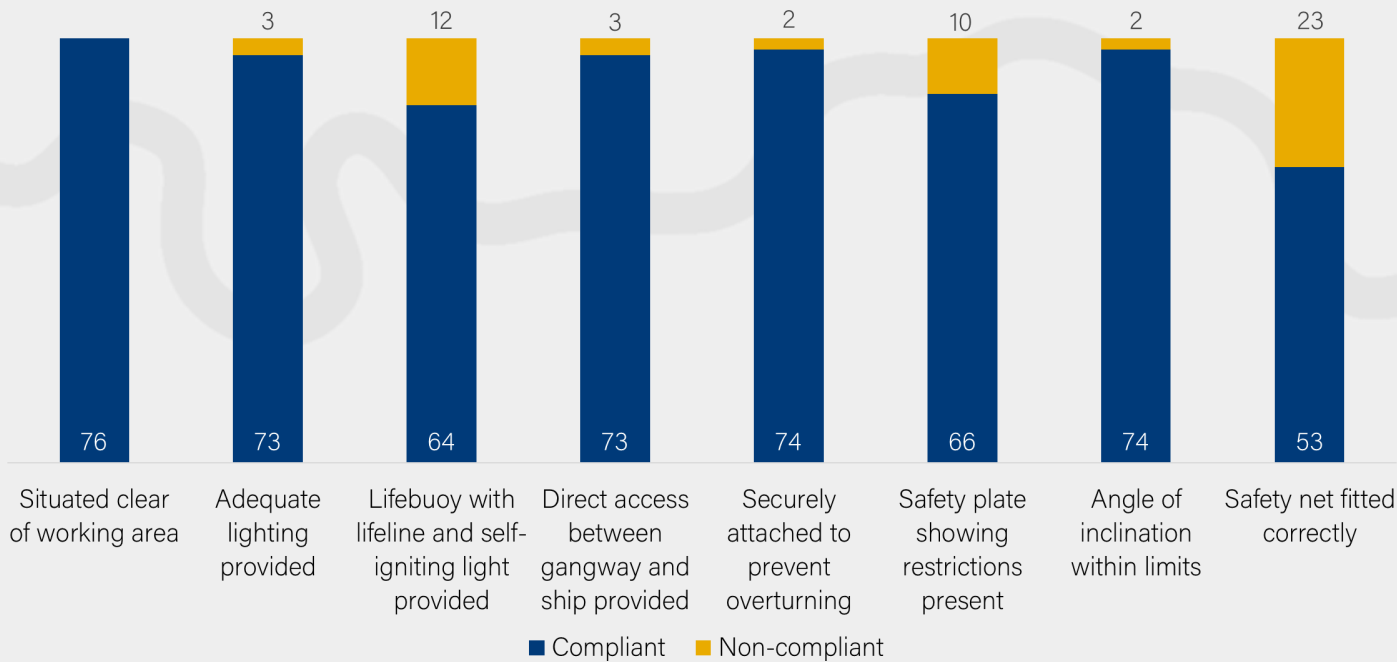
80% of all gangways inspected¹ were found to be compliant. The graph below depicts the areas checked when inspecting a gangway. The main issues encountered were that 30% did not have a safety net fitted correctly, whereas 16% did not have a lifebuoy nearby and 13% were missing signage showing the restrictions of safe use.

The condition of gangways was considered **Satisfactory** in the following areas:

- Overall cleanliness: **99%**
- *Wires: **84%**
- Stanchions/Hand holds: **99%**
- Hand ropes/rails: **99%**
- *Turntable: **100%**
- *Lifting points: **100%**

1% of gangways had issues with the condition of wires*, stanchions and hand ropes.

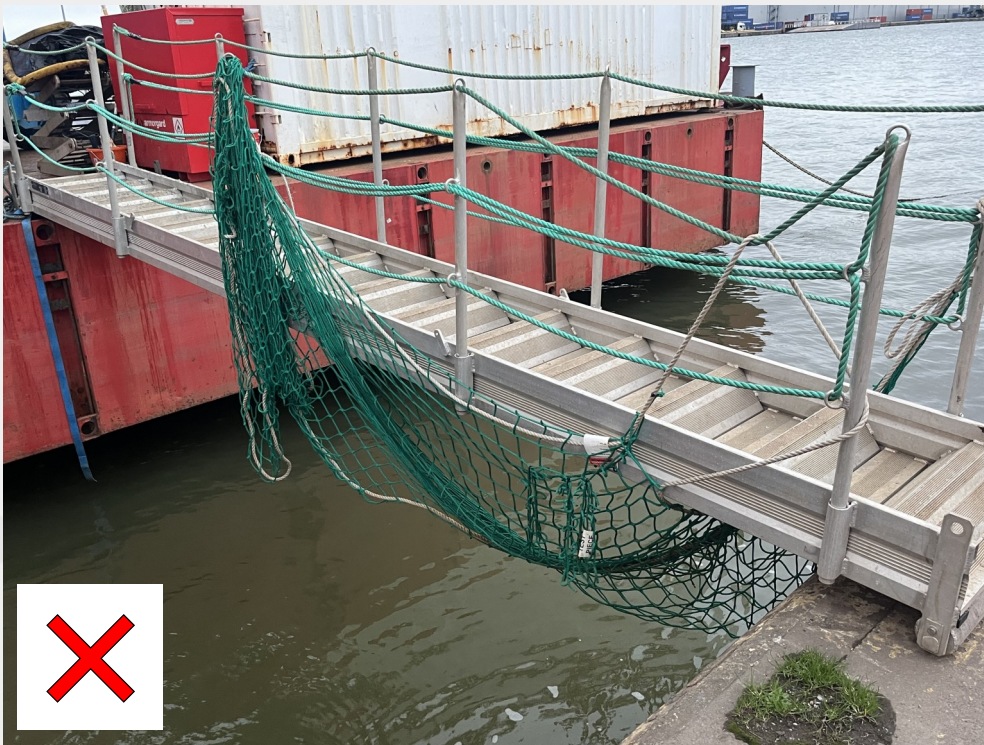
Common issues with Gangways: Safety Nets rigged incorrectly

It is a common misconception that gangways, with a net that wraps around the gangway and only covers the sides and bottom do not require a separate safety net. This net will not catch you if you fall off, that is why you need a safety net which is fitted around the entire length of the gangway.

The Code of Safe Working Practices for Merchant Seafarers (COSWP) provides guidance to crew of vessels operating in UK waters. Chapter 22, Boarding Arrangements, Section 22.3 states that “where there is a risk of a person falling from the access equipment or from the quayside or ship’s deck adjacent to the access equipment, a safety net must be mounted where reasonably practicable.

“The aim of safety nets is to minimise the risk of injury arising from falling between the ship and the quay or falling onto the quay, deck or between two vessels. As far as is reasonably practicable, the whole length of the means of access should be covered. Safety nets should be securely rigged, with use being made of attachment points on the quayside where appropriate.”

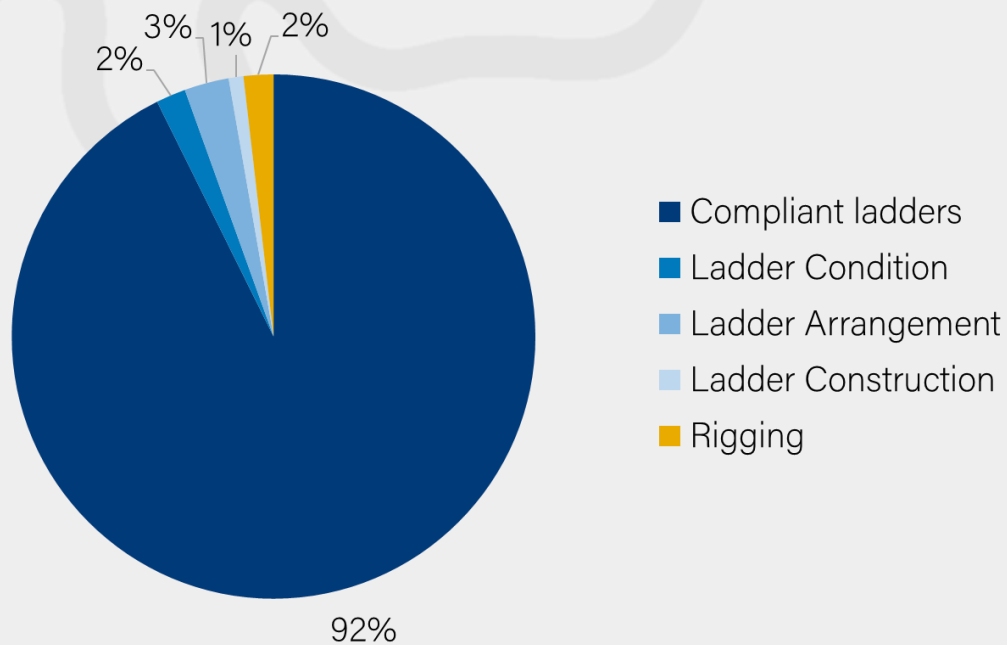
109 Pilot Ladders

92% of all pilot ladders inspected during Safe Boarding Week were found to be compliant with **SOLAS** (International Convention for the Safety of Life at Sea regulations) standards.

Of the **eight** deficiencies, only **two** of our Pilots were able to identify the deficiency **prior** to boarding, while **six** stated that they only became aware of the deficiency **once onboard**.

Any non-compliance was reported in our Incident Management System and to the Maritime & Coastguard Agency.

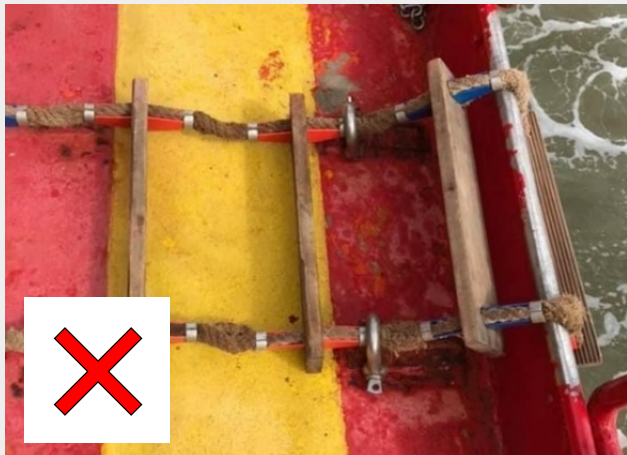
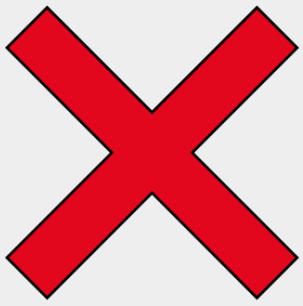
Pilot Ladders secured by shackles

Common issues with Pilot Ladders: Securing by shackles

Pilot Ladders secured by **shackles** are a common deficiency. This is because, although **Resolution A.1045(27) Section 2.1.1** of the International Maritime Organisation (IMO) allows it: "The securing strong points, shackles, and securing ropes should be at least as strong as the side ropes", it must be noted that the UK Maritime & Coastguard Agency (MCA) has declared the use of shackles as **non-compliant**. When secured by shackles, the weight of the ladder is placed on the steps rather than the side ropes, so when the Pilot puts weight on the ladder, the ladder will move freely under the shackles until the next chocks and step has reached the shackles. This can cause serious injury to the Pilot.

Pilot ladders should be secured using **rope lashings** to a deck strong point using a rolling hitch or appropriate hitch to secure the side ropes. The strong point should be at a distance of not less than 915 mm measured horizontally from the ship's side inwards.

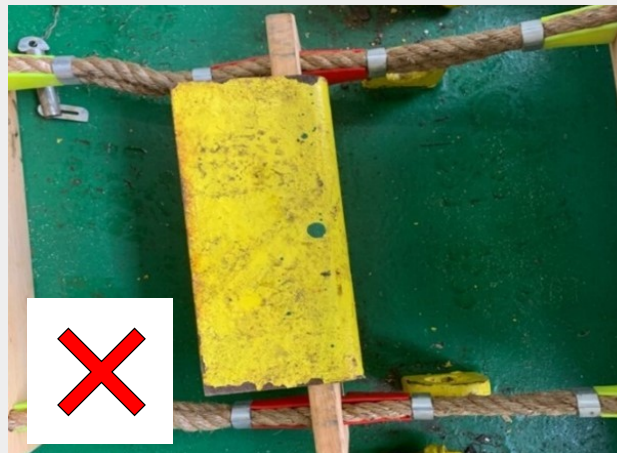
Pilot Ladders secured by deck tongue

Common issues with Pilot Ladders: Securing by deck tongue

Although a common securing arrangement which may appear a simple solution to install and adjust a pilot ladder, this method is deemed **non-compliant** in the UK and dangerous for anyone who might have to use it. Applicable regulations:

ISO799-1(2019) states that: "each side rope shall have a breaking strength of at least 24kN and the diameter should be 18mm."

ISO799-1(2019) states that "each step shall have a strength of at least 8,8 kN"

IMO1045(27) 2.1.1 "the securing points...shall be at least as strong as the side ropes"

Therefore, each side rope can handle 2,400kg (4,800kg together) but each step can only handle a weight of 880kg. This means that by resting the entire weight of the ladder on just one step by using a deck tongue, puts a dangerous strain on the step which could cause it to break causing the ladder to fall. The strength of the deck tongue is often unknown. In most cases it is not tested or certificated either.

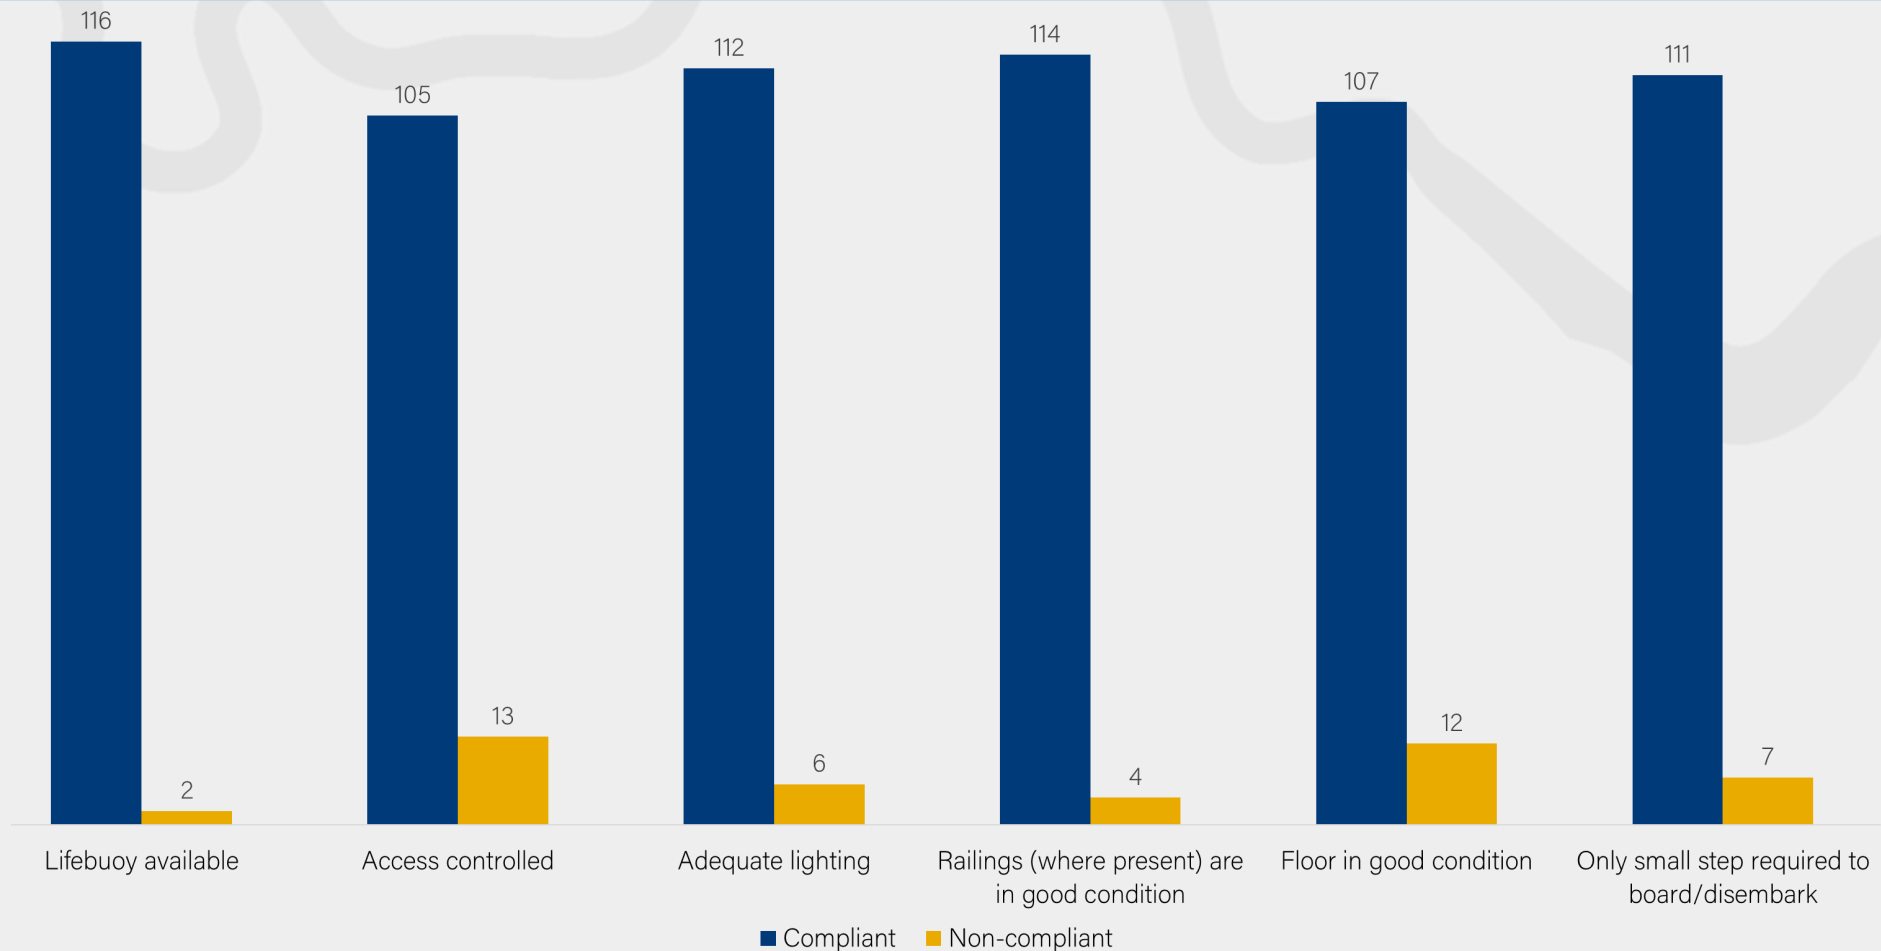
118 Pier inspections

91% of all piers inspected were found to be compliant. The graph below depicts the areas checked when inspecting a pier or other location where embarkation/disembarkation is achieved by stepping onto/off the vessel. We are working with operators to address issues around access control, lighting and general condition.
