NABSO

Pilot Transfer Arrangements

NABSO13-24

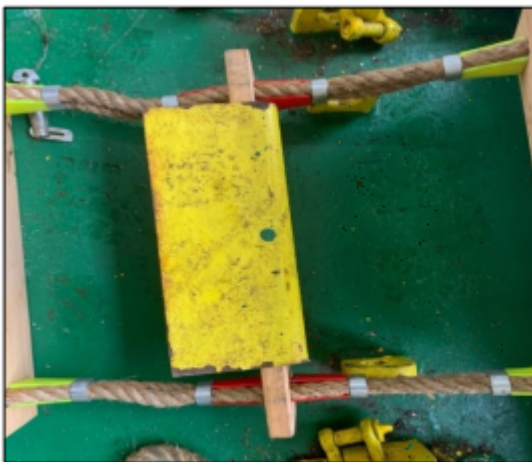
Pic 1 Ladder Secured by Deck Tongue

PILOT LADDER SECURED BY DECK TONGUE

Although a common securing arrangement which may appear a simple solution to install and adjust a Pilot ladder, this method is deemed non compliant in the UK and dangerous for anyone who might have to use it. Applicable regulations:

Therefore, although each side rope can handle 2,400kg (4,800kg together) and each step can handle a weight of 880kg, the strength of the deck tongue is often unknown nor tested and certificated.

ISO799-1(2019) states that: *“each side rope shall have a breaking strength of at least 24kN and the diameter should be 18mm.”*

ISO799-1(2019) states that *“each step shall have a strength of at least 8,8 kN”*.

IMO1045(27)2.1.1 *“the securing points etc shall be at least as strong as the side ropes”*.

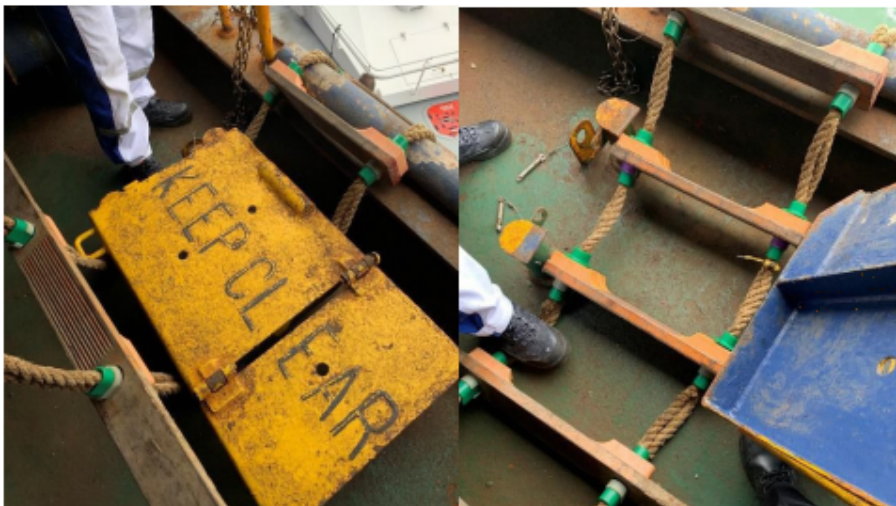
Pic 3

PLATFORM PLACED OVER THE SECURING AREA OF THE LADDER

A compliant platform built over the securing area of the Pilot ladder can be seen to improve access but can hide a non-compliant securing arrangement. (Pic 2 & 3)

Pilots who encounter a platform over the ladder will often ask to check the securing arrangement. Should this be found non-compliant it may be reported as a deficiency to the Port Authority & local MCA office.

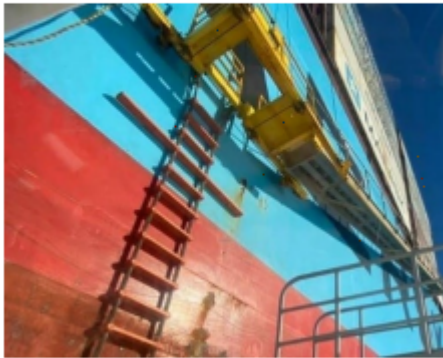
Pic 4

EMBARKATION PLATFORM - TRAPDOOR SYSTEM

Where the vessels freeboard exceeds 9m, an arrangement consisting of both accommodation and Pilot ladders must be used. Some vessels are still presenting arrangements with a trapdoor which has not met IMO standards since 2012. (Pic 4)

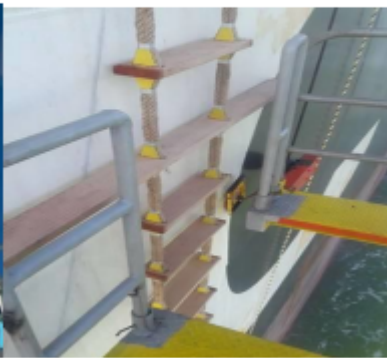
Pic 5

IMO A.1045(27)3.7 states the ladder has to “extend above the lower platform to the height of the handrails” and remain in alignment with and against the ship’s side. (Pic 5)

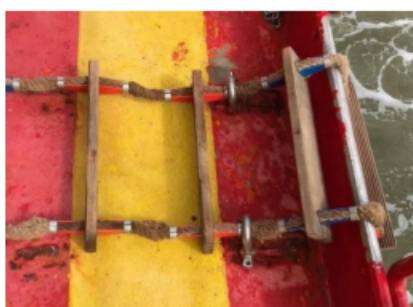
Pic 6

SECURING PILOT LADDER WITH SHACKLES

Shackles are a common Pilot ladder securing deficiency. This is because although the IMO allows it **IMO A.1045(27)**: 2.1.1 “the securing strong points, **shackles**, and securing ropes should be at least as strong as the side ropes” it must be noted that the **UK Authorities have declared the use of shackles as non-compliant**, because this puts weight on the steps rather than the side ropes. When the Pilot puts weight on the ladder, the ladder will move freely under the shackles until the next chocks and step has reached the shackles.

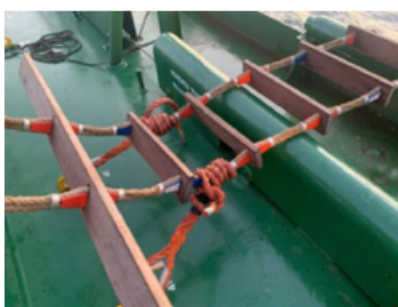
Pic 7

Pilot ladders should be secured using rope lashings to a deck strong point using a rolling hitch or appropriate hitch to secure the side ropes. The strong point should be at a distance of not less than 915 mm measured horizontally from the ship's side inwards. (Pic 7)

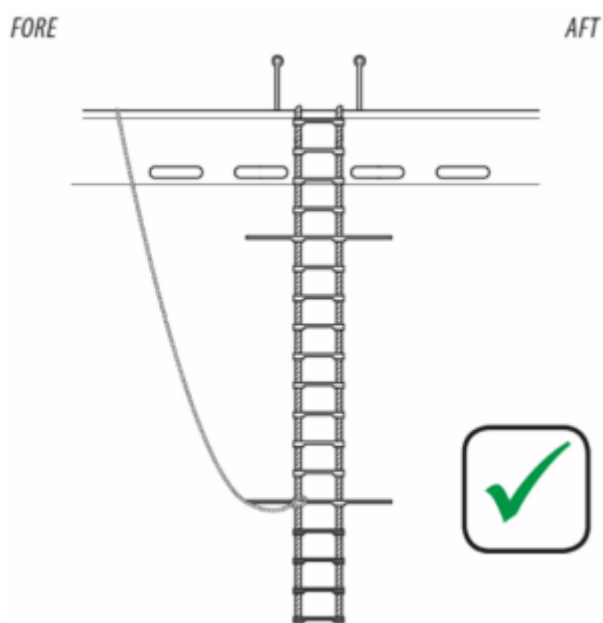
SAFE RIGGING OF RETRIEVAL LINES

Retrieval lines (sometimes called tripping lines) are often used to lift the Pilot ladder. These lines are potentially dangerous, they may foul the Pilot vessel or be a hazard to the Pilot's feet. When a retrieval line is considered necessary to ensure the safe rigging of a Pilot ladder, the line should be fastened at or above the last spreader step and should lead forward. The retrieval line should not hinder the Pilot or obstruct the safe approach of the Pilot boat. (Pic 8)

IMO Resolution A.1045(27) 2.1.5

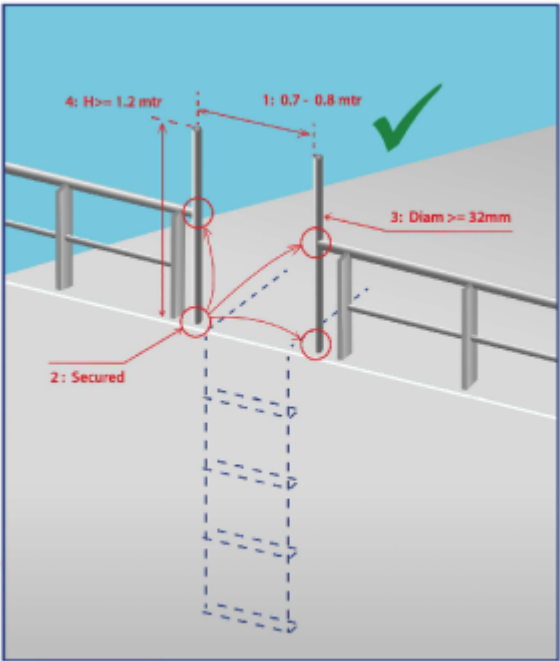
Pic 9

STANCHIONS

SOLAS V Reg 23 & IMO Res 1045 (27) states:

Stanchions to be at least 1.2 metres above the deck/bulwark. (Pic 9)

To be a minimum of 70 cm and maximum of 80 cm apart.

Stanchions are to have a minimum diameter of 32mm, in order to provide a firm grip. (ISO 799- 3:2022 now also details a maximum diameter of 36mm)

Each stanchion to be rigidly secured at or near the base and at a higher point. (There shouldn't be a gap at the base of the stanchion to facilitate rigging for the spreaders)

The absence of suitable handholds & stanchions can lead to serious accidents. Unfortunately, in many cases, when it comes to the proper use of handholds or stanchions, ships are non-compliant by design. All vessel those who fall under an older version of SOLAS should still ensure they make every effort to enable Pilots to embark and disembark safely.
